Project: CRSWSC Master Plan

Subject: CRSWSC Master Plan - Scenario 5 Update

9 FACILITY ASSESSMENT

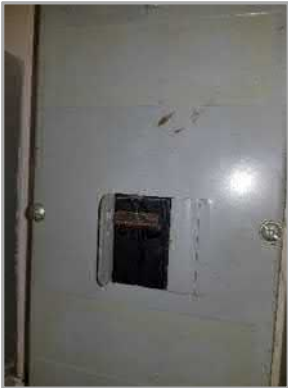
Rusted MCB

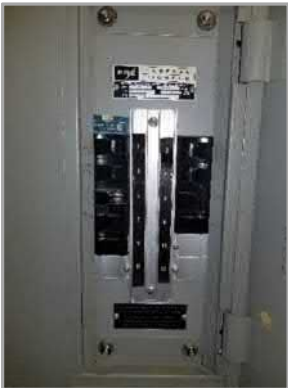
Rusting Distribution Panel

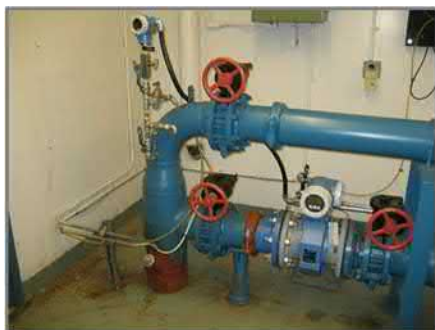
Paint Fill Piping

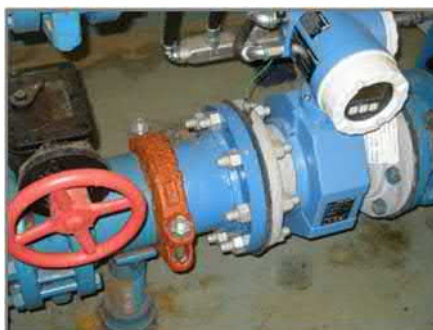
Superficial Rust

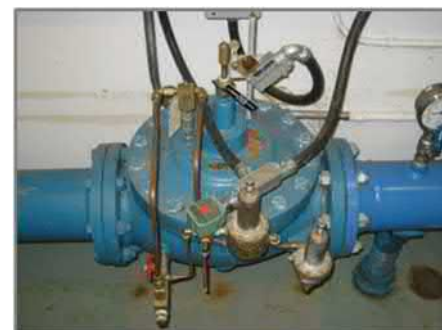
Re-build PSV/PRV

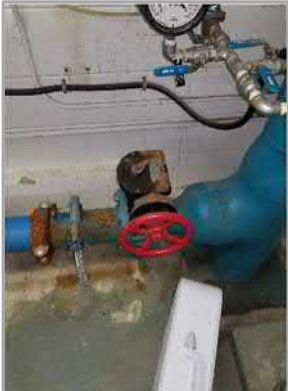
Rusted Piping and Valve

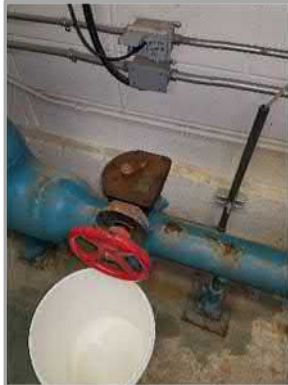
Rusted Valving and Piping

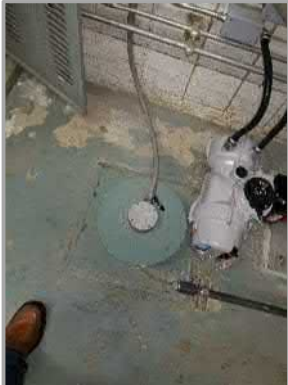
LIT Access - Is Water Return Sealed?

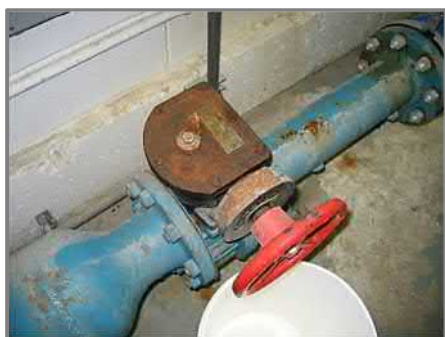
Significant Corrosion

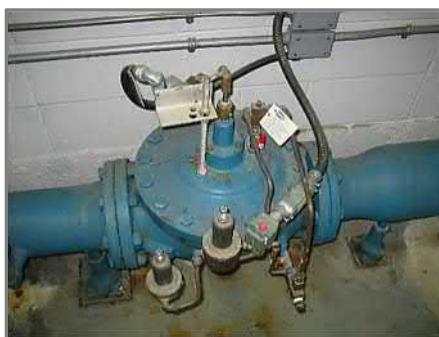
Rebuild PSV/PRV

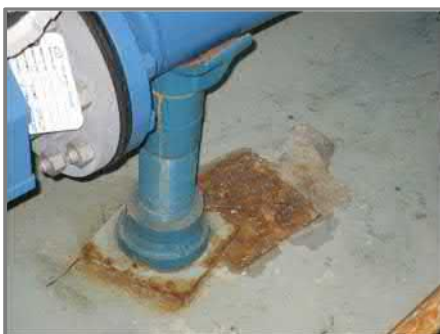
Pipe Support Rust

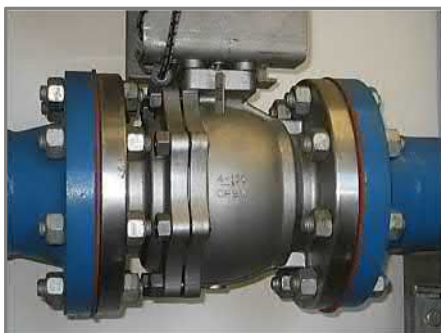
- Piping and equipment are in generally good condition.
- The flow control valve appears to be installed backwards. While functional this will render any anti-cavitation trims useless and result in excessive valve wear.
- Pressure gauge PI-0200 is “pegged”. Consider a gauge with a higher range (see EIC photos).
- Remove/replace galvanized fittings on instrumentation piping.

Flow Control Valve Reversed

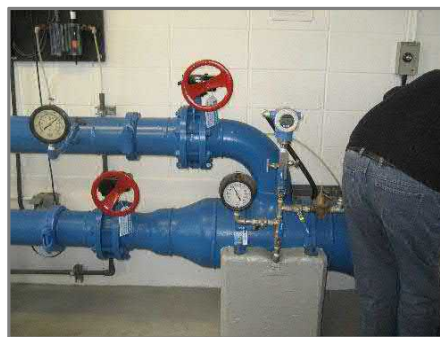
ARV & Galvanized Fittings

- Piping and valves are in generally good condition.
- PRV appears to be in good condition based on the lack of corrosion observed. Recommend a rebuild kit be considered to ensure the PRV/PSV continues to function correctly for the future. This includes replacing the PRV pilot solenoid as it appears original and is likely nearing end of life.
- Consider installation of an air release valve in the influent bypass elbow. This will eliminate any entrained air before it can affect any of the downstream instruments.
- Remove galvanized fittings on instrumentation piping.

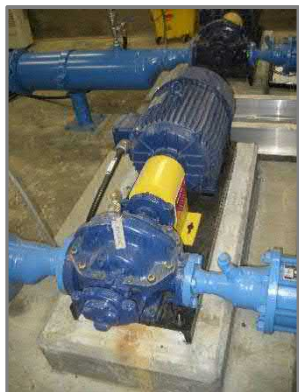
Head Bolts – Superficial Rust

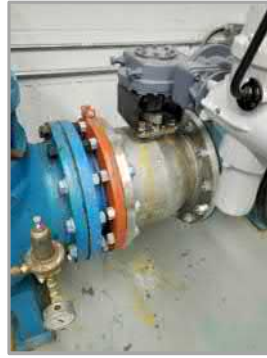
Flow Control Valve; Rust Stains

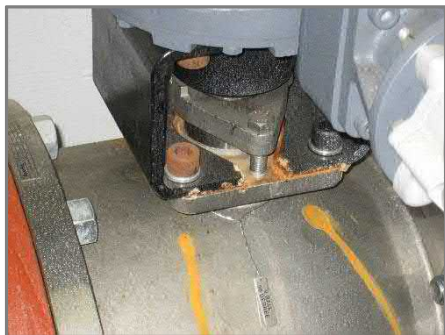
FCV Actuator Bolts Corrosion

- The flow control valve, actuator, flow meter, and piping are all recent upgrades from the last SCADA upgrade for the PLCs and, with the exception of some rust stains on the flow valve bod, are in good condition. The bolts holding the actuator to the valve should be changed out to SS to avoid further corrosion.
- PRV appears to be original and has been painted recently. Recommend a rebuild kit be considered to ensure the PRV/PSV continues to function correctly for the future. This includes replacing the PRV pilot solenoid as it appears original and is likely nearing failure as it is near its end of life.
- Surface blemishes on the piping appear to be scuff marks, rather than corrosion induced. Exposed areas should be touched up to prevent corrosion.

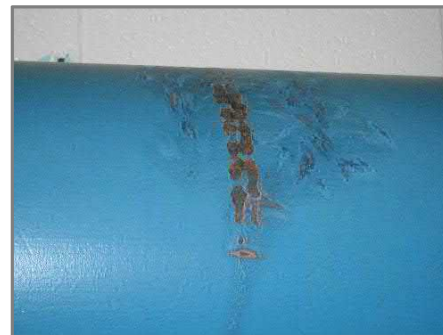
Pipe Surface Scuffing

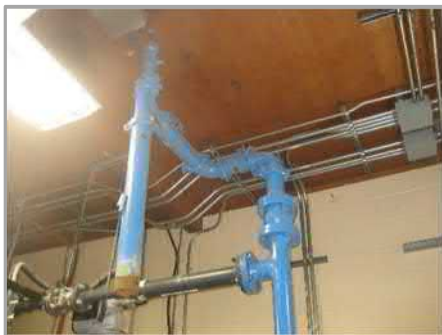
Corrosion & Open-ended Pipe

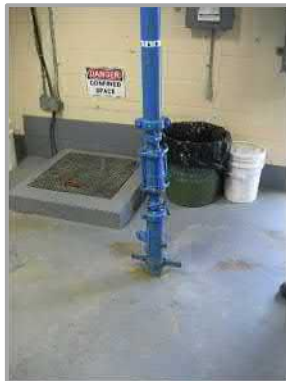
Pipe Stability Concerns

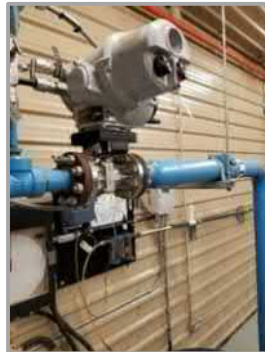
Flow Valve; Rusting

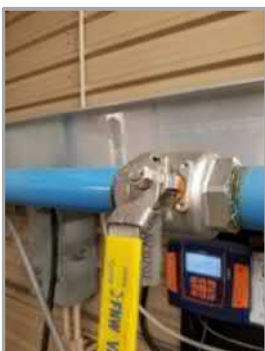
Rusting Isolation Valves

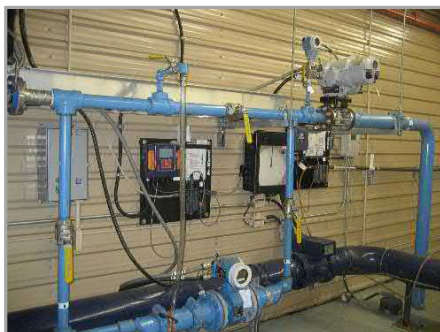
- The fill system is a mixture of carbon steel and stainless-steel piping. The piping is in generally good condition, although there is some superficial rusting on the flanges holding the control valve, and on some of the threaded fittings.
- Control valves are in good condition and appear to be functional.

Corrosion on Fittings

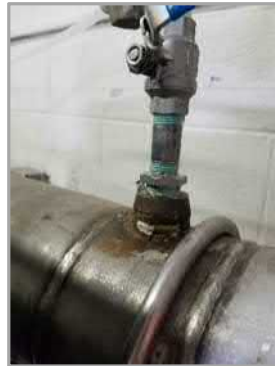
Corroding NPT Weld

- Piping (and valves) are all stainless steel. Piping is in generally good condition; the welding is very poor.
- Valves are relatively new and in good condition. All appear to be functional.
- PRV blocks access to the level transmitter.
