Project: CRSWSC Master Plan

Subject: CRSWSC Master Plan - Scenario 5 Update

9 FACILITY ASSESSMENT

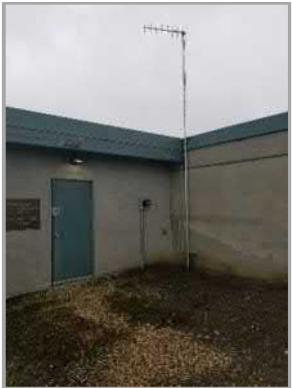
Antenna and Power Meter

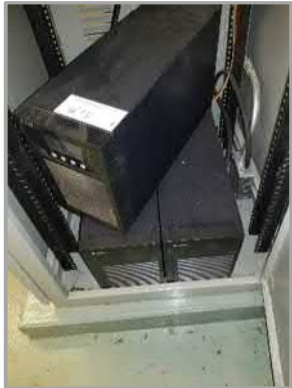
UPS Stack

- PLC cabinet UPS has two battery pack power extenders. These need replacement every 5 years on average. Recommend replacement of the batteries to maintain the system runtime.

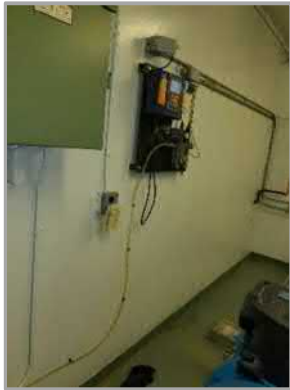
- The chlorine residual analyser is a ProMinent unit. The incoming water feed has an air trap potential. The pipe tap should always rise or fall so air cannot get trapped in the line. Recommend re-routing the water line to eliminate the air traps.

Analyser Feed Line

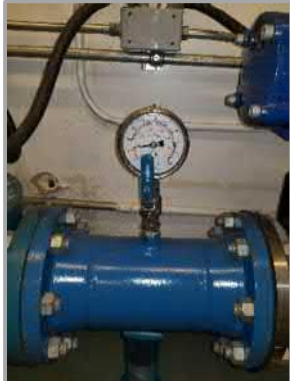
- The pressure gauge between the pressure reducing valve (PRV) and flow valve needs a neck extension. The isolation valve handle obscures the face. The gauge is also smaller than the normally recommended 4" dial face.

Blocked Gauge

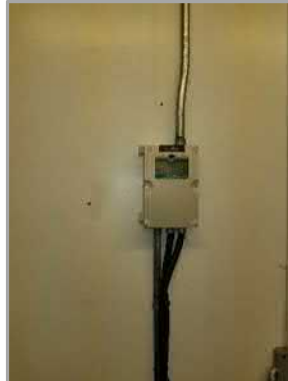
- The Level Transmitter (LIT-0580) is a Siemens Milltronics MultiRanger 100 unit and appears to be in good condition. It was not possible to determine if the unit was installed correctly as the transmitter is located in the adjacent room.

Level Transmitter

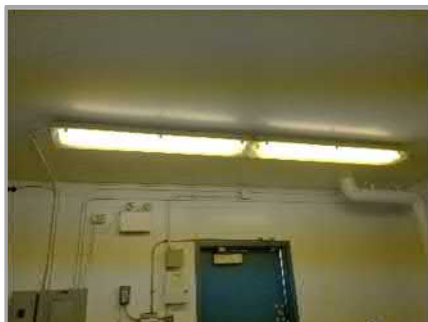
- An emergency wallpack is present; however, the ability of an old unit like this to provide the 30 minutes of emergency lighting is unlikely. Also, there is no illuminated exit sign over the doorway. Recommend a new emergency exit sign with lights be installed next to the door (include auto exerciser option) to resolve both issues.

Lighting and No Exit Light

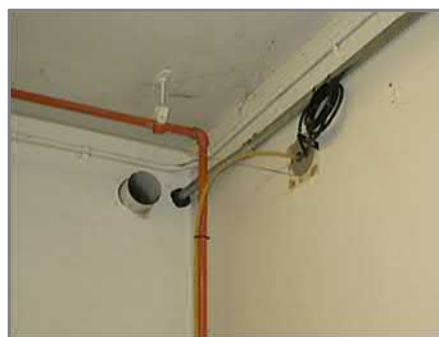
Open Duct.

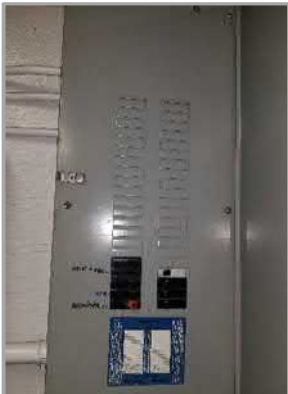
- The main breaker looks to be relatively new as does the distribution panel.
- The distribution panel is oversized for such a small space given there are only 9 circuits fed out of 42. The main distribution panel appears to be in good condition for original equipment; however, an internal inspection for pitting or corrosion is prudent and replacement if corrosion is found. This is mentioned here due to the significant pipe corrosion observed.

Oversized Distribution Panel

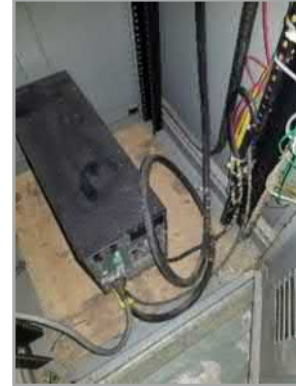
UPS Mud Covered

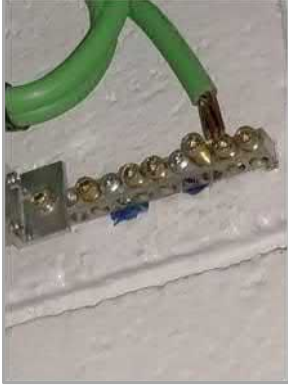
Ground Not Connected

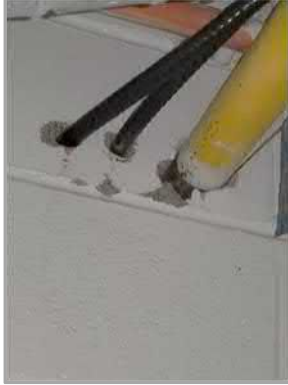
Penetrations Not Sealed

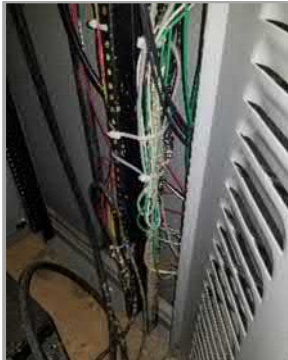
Mud Covered Wiring

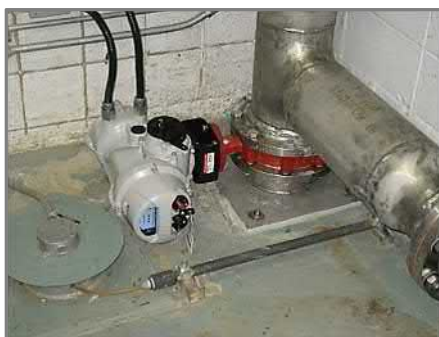
Valve Actuator Orientation

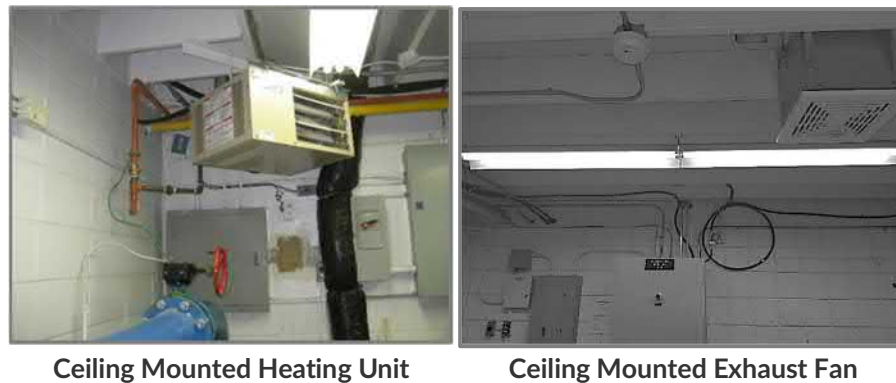
- The room is equipped with a ceiling-mounted gas furnace. Based on observation, the unit appears new.
- At time of inspection, a box fan was located in room. AE have assumed that the box fan was to improve air movement within the room.
- Recommend that the ventilation within the building be reviewed, to ensure that the ventilation requirements are met.
- The ceiling mounted gas furnace should be clean and inspected yearly.

Ceiling Mounted Heating Unit

Ceiling Mounted Exhaust Fan

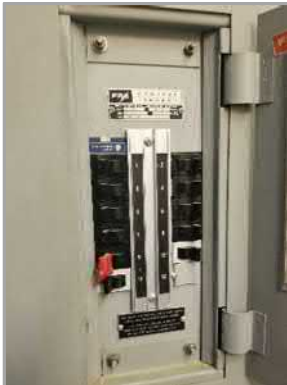
- The main breaker looks to be visually in good shape, but the internals should be checked and replaced if corrosion is found.
- The main distribution panel appears to be in good condition for original equipment; however, an internal inspection for pitting or corrosion is prudent, with replacement if corrosion is found. Rust is observed on the lower corners of the panel suggesting that corrosion is occurring inside the panel due to excess moisture.

- The venting of this room needs to be examined as the rust observed is indicative that excess moisture is present.
- There is a smoke detector on the ceiling, and it appears relatively new. This should be replaced in 5 to 10 years with a suitable unit to provide an alarm contact.

Distribution Panel

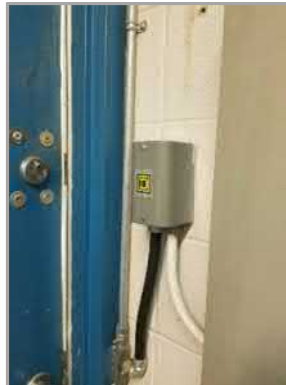
- An old Schneider power fail relay is seen on the wall. This is assumed tied to the SCADA. Replace when it fails, otherwise it has no operational impact.

Power Fail Relay

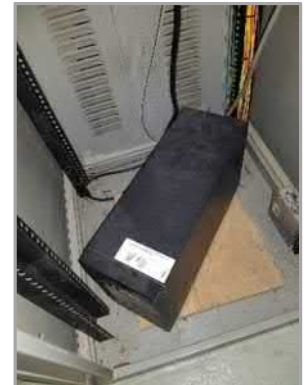
- The pipe appears to be well grounded.
- PLC cabinet UPS is a single unit. UPS batteries should be replaced every 5 years on average.
- An original design telephone entrance panel is present. This panel is not in use.

UPS

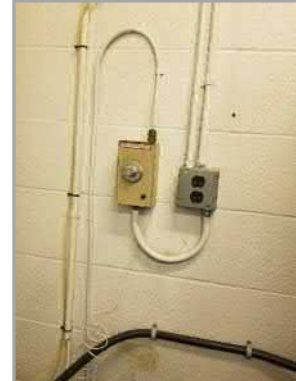
- There is a Pyrotex inline heat tracing system for the water line. This system appears to be original to the facility. Recommend updating to a newer GFI system to meet current Electrical Code.

Heat Trace Controller

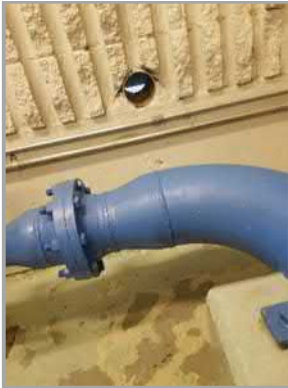
- There is a wall penetration near the PRV through which daylight can be observed. This hole should be sealed to prevent water or vermin ingress.
- Active cathodic protection is installed. This appears to be functional, but is outside of AE's expertise to determine the condition.

Hole to Outside

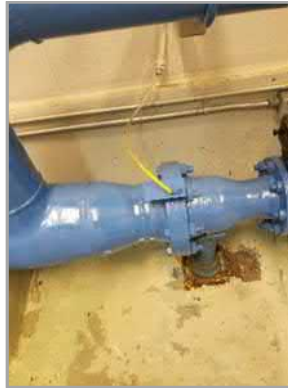
Pipe Grounding

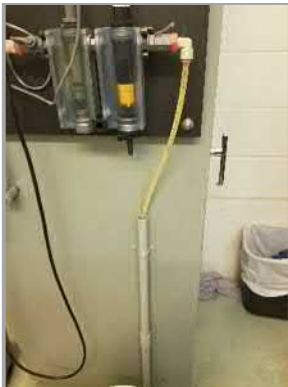
- The drain line runs directly into a drain pipe that empties into the reservoir. An air gap is recommended to prevent drain contaminants from crawling up the hose into the analyser chamber. Recommend either adding a funnel at the top of the drain pipe stack and position the hose to drop the drain water into the funnel with an air gap, or, insure that where the drain hose returns to reservoir it is air gapped.

Drain Line Needs Air Gap

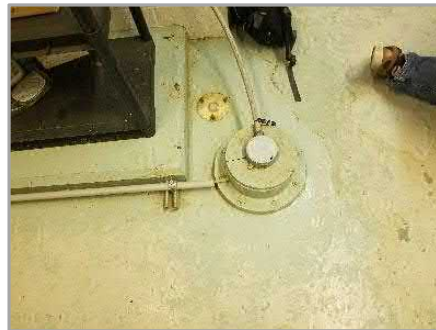
- An additional note on the analyser drain line; where it enters the floor flange to drain back to the reservoir does not appear to be well sealed. This could allow floor wash water to enter the wetwell. Recommend this hole be sealed with caulking to prevent water contamination.
- The level transmitter is a Milltronics MiniRanger Plus unit and appears to be in good condition. The element penetrates the floor just in front of the transmitter. The floor penetration is well covered.

Drain Line and Level Element

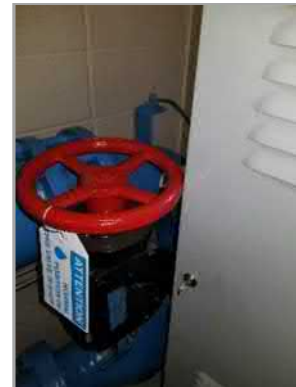
- The cabinet has a Sixnet 5 port managed ethernet switch for future communications and PLC access.
- Terminals and wiring appear in good condition.
- The rear door cannot open past the manual isolation valve.

Valve Blocks Rear Cabinet Door

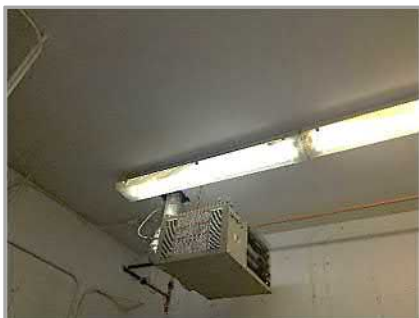
- Lighting appears to be original fluorescent fixtures, and since the lights are off 99% of the time there is little benefit to upgrading these to LED. However, water damage to several of the lights can be observed and the source of the water needs to be determined, and the damaged fixtures replaced with new LED units.

Stained Lighting

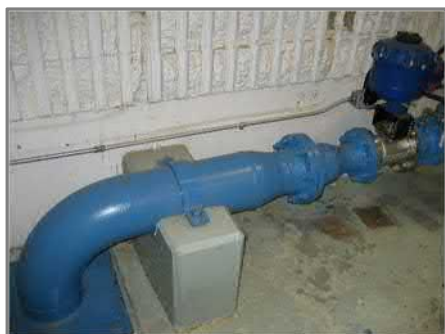
- Valve actuators and piping do not show signs of corrosion. Piping appears to have been painted in the last few years.
- There is some rusting where pipe supports have been moved/relocated.
- PRV appears to be in good condition based on the lack of corrosion observed. Recommend a rebuild kit be considered to ensure the PRV/PSV continues to function correctly for the future. This includes replacing the PRV pilot solenoid as it appears original and is likely nearing end of life.

Piping Condition

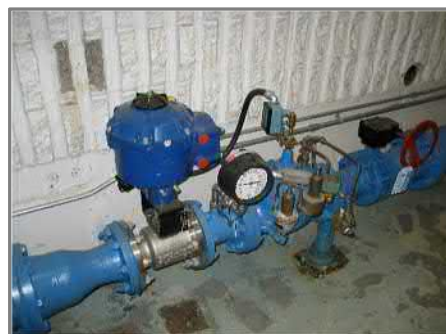
Valve Condition

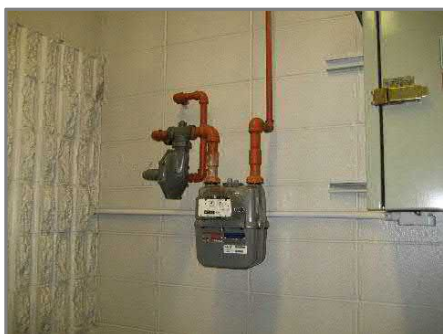
- The room is equipped with a ceiling mounted gas furnace. Based on observation the unit appears newer.
- The gas meter is located within the meter room. When the meter is upgraded by the utility company, the gas meter should be relocated to the outside of the building.
- Wall penetration near the PRV should be filled.
- There is a partial dividing wall between the Commission's meter room and the County's pump room. Due to the shared space the heating and ventilation requirements for the space should be reviewed with the County.

Gas Meter

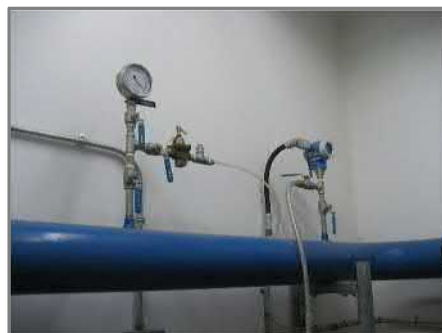
- Piping and equipment are in generally good condition.
- The flow control valve appears to be installed backwards. While functional this will render any anti-cavitation trims useless and result in excessive valve wear.
- Pressure gauge PI-0200 is “pegged”. Consider a gauge with a higher range (see EIC photos).
- Remove/replace galvanized fittings on instrumentation piping.

Remove Galvanized Fittings

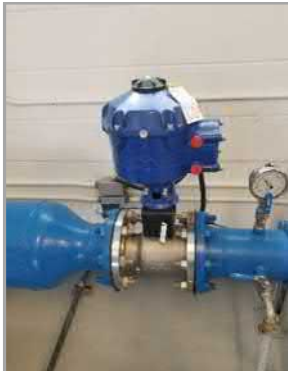
PRV

- Piping and valves are in generally good condition.
- PRV appears to be in good condition based on the lack of corrosion observed. Recommend a rebuild kit be considered to ensure the PRV/PSV continues to function correctly for the future. This includes replacing the PRV pilot solenoid as it appears original and is likely nearing end of life.
- Consider installation of an air release valve in the influent bypass elbow. This will eliminate any entrained air before it can affect any of the downstream instruments.
- Remove galvanized fittings on instrumentation piping.

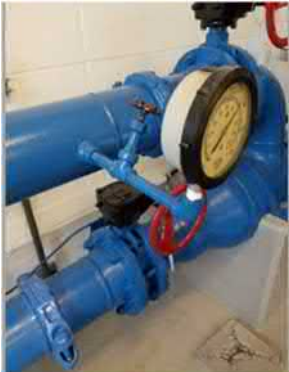
Yellowed Gauge

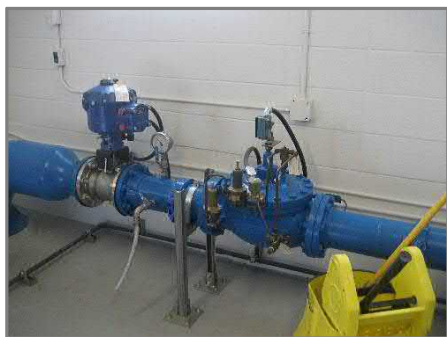
Piping, Valves Condition

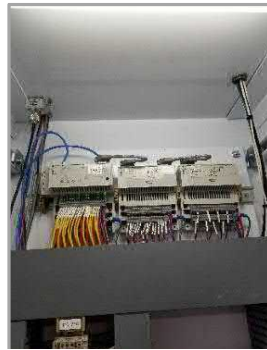
PLC Rack

The control system PLC is a Schneider Momentum PLC, and the radio is a GE MDS SD4 licensed radio. The Momentum is still a current platform. During the last SCADA upgrade this station was too new to be upgrade, but sufficient years have passed that it is now due to be upgraded to meet the current Commission System. An M340, or the newer M580 is the recommended platform.

- No HMI exists at this facility. Because this facility contains pumps, AE recommend a small touchscreen interface be added to allow operator access to status and local setpoints. The HMI should be password protected with appropriate operator access levels. Recommend this occur at the same time the PLC is upgraded.

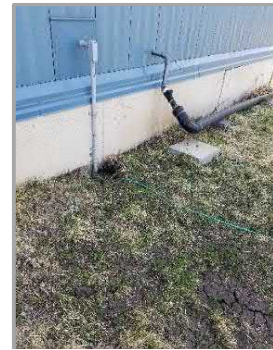
- When onsite, it was noted that someone had stolen/cut the original ground grid. A temporary ground cable had been installed but the new cable has yet to be buried into the ground to protect it.

Temporary Ground

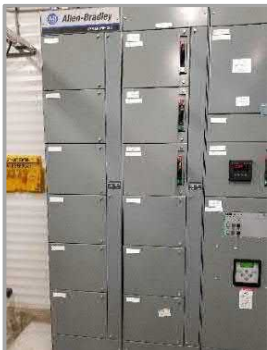
- The MCC appears to be in good condition with no obvious signs of corrosion, and given its age it has at least another 15 years of life. There is a good section and a half of spare space provided. Expansion physically is not an issue for this MCC.

MCC

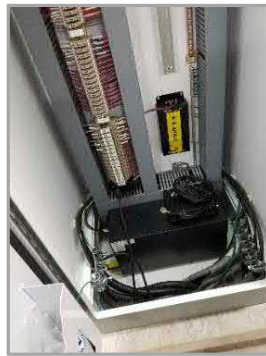
- PLC cabinet UPS is a single unit. UPS batteries should be replaced every 5 years on average.
- A Sola Hevi-Duty Power Conditioner is installed to filter the power going to the UPS. After 10 years this filter needs to be closely inspected for wear and damage, and replaced if any is found. These units have shown a tendency to wear out and fail if exposed to significant line noise after several years while doing their job of noise filtering. Less expensive options that perform the same function now exist, such as AEGIS Power filters.

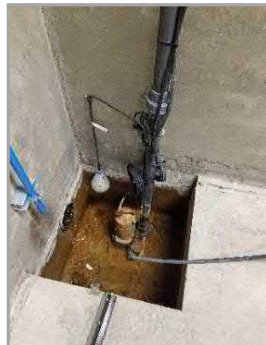
Sump

- The sump pump in the basement appears to operate often if the flow rate of water to the sump is any indication. Operators test the sump, but replacement is recommended after 10 years of repeated use before it fails. Debris appears to have been swept into the sump pit, a cleanup is recommended to prevent debris and other matter from clogging the pump.

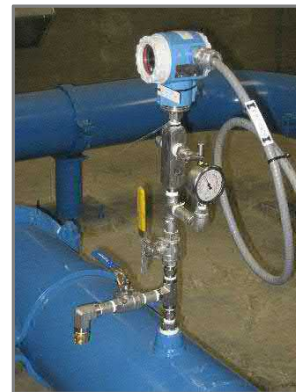
Galvanized Fittings

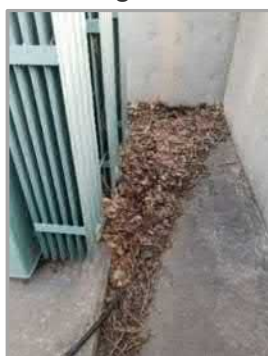
Debris Behind Transformer

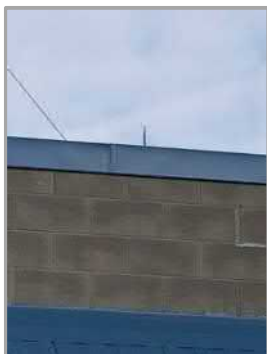
Lightning Protection Spike

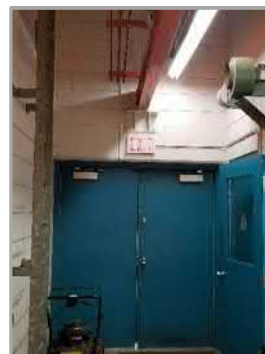
Main Entrance: No Emerg. Lighting

- An emergency wallpack is present over the door but the ability of an old unit like this to provide the 30 minutes emergency lighting required is unlikely. Also, there is no illuminated exit sign over the doorway. Recommend a new emergency exit sign with lights be installed over the door (include auto exerciser option) to resolve both issues. An Exit sign will require a dedicated power circuit.

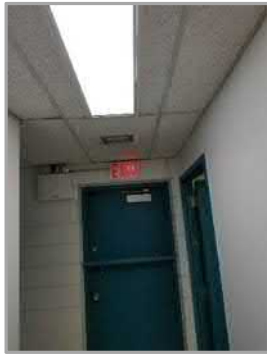
Rear Exit Sign Half Lit

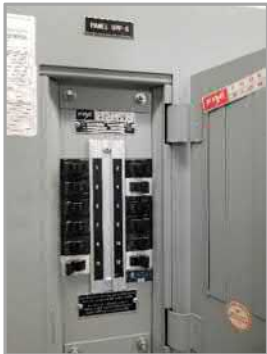
Distribution Panel

- The main distribution panel has surface corrosion and an internal inspection is recommended. With knowledge that this panel is almost as old as the MCB and the presence of rust, replacement is recommended. Rust implies this panel has been exposed to moisture for a long period of time.

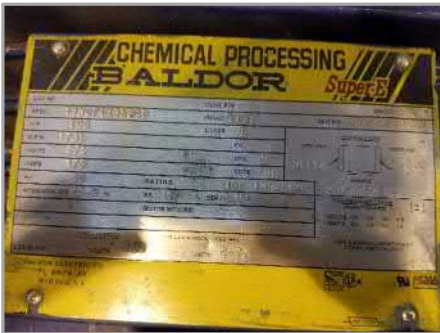
Motor Nameplate:
Not Inverter Duty

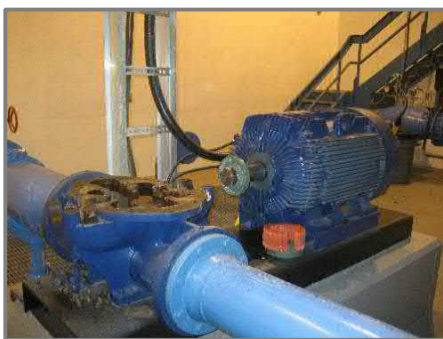
P-102 Dismantled for Service

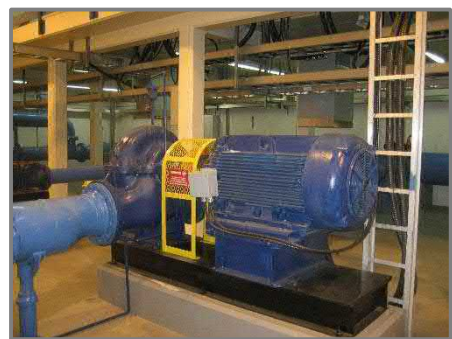
- The piping and equipment are in generally good condition.
- There is no evidence of rust, although there is a calcium build-up on the bearings of P-103.

P-103

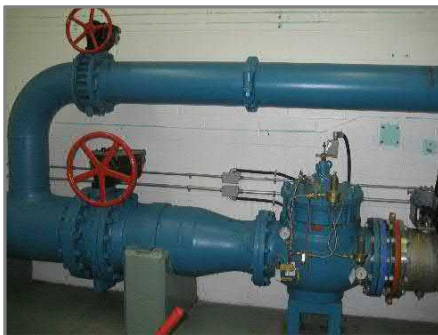
PSV and Piping - Condition

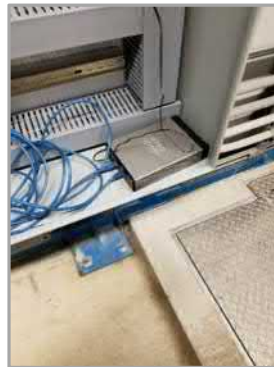
Internet Router

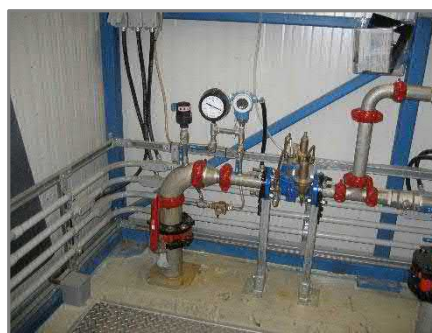
**Image Table 2-21
Hamlet of Armenia - Valves and Piping**

- Piping is all stainless steel and is in generally good condition.
- All valves, equipment, etc. appears to be functional.

Valves and Piping

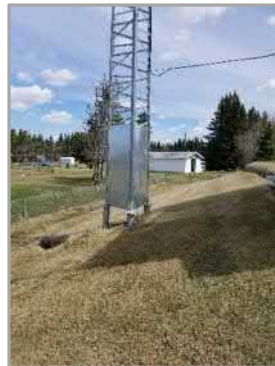
Radio Tower Grounding

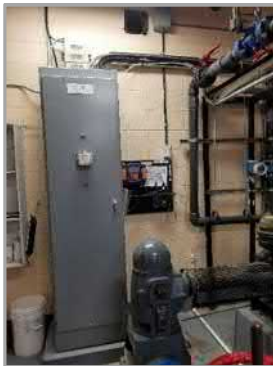
- PLC cabinet wiring is in good condition.
- The original MDS 4710 radio and an additional SD4 radio are still in the cabinet. The 4710 should be recycled and the spare SD4 radio stored at the Master station as a spare not left in the cabinet.

PLC Cabinet

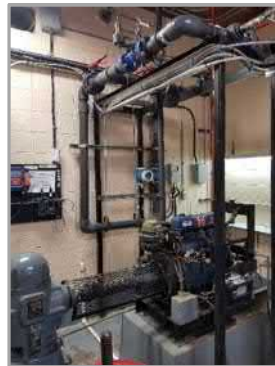
- The fill piping is PVC and is overhead due to space restrictions at the time of the original installation.
- Instrumentation is newer E&H pressure and flow meters, and is in good condition. PITs overhead are angled downwards for local visualization.

General Fill Piping

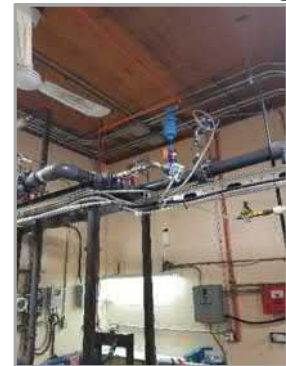
PIT Angled Down

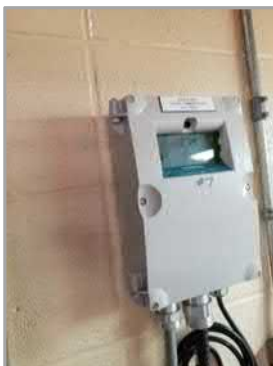
- The Commission has a dedicated level transmitter, a Siemens Milltronics unit that is also in good condition. The magnetic control pad is mounted inside the PLC cabinet for safe storage.

Level Transmitter

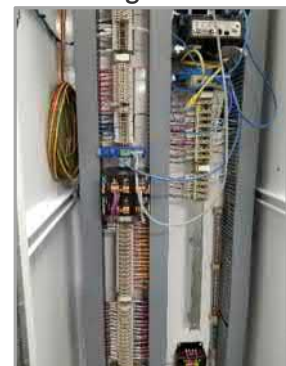
PLC Wiring and Radio

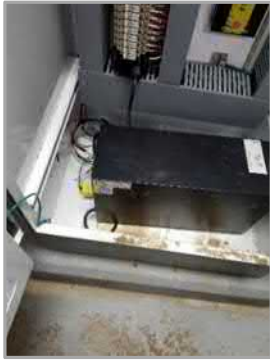
- A Sola Hevi-Duty power conditioner is installed to filter the power going to the UPS. After 10 years this filter needs to be closely inspected for wear and damage and replaced if any found. These units have shown a tendency to wear out and fail if exposed to significant line noise after several years while doing their job of noise filtering. Less expensive options now exist like AEGIS Power filters that performs the same function.
- Single EATON Powerware UPS in cabinet. UPS batteries should be replaced every 5 years.

UPS

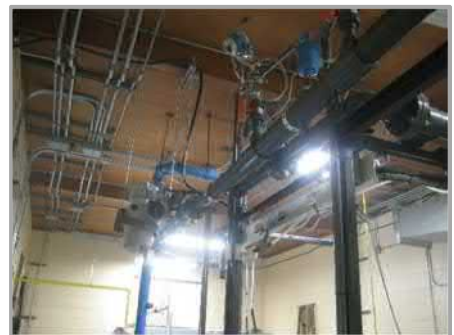
Elevated Controls

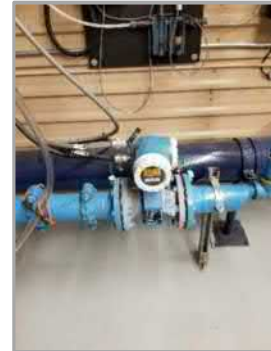
- The piping is a mixture of threaded and flanged components. Corrosion is found on several flanges and needs to be addressed.
- The E&H flow meter has grounding rings and is grounded correctly.

Flowmeter

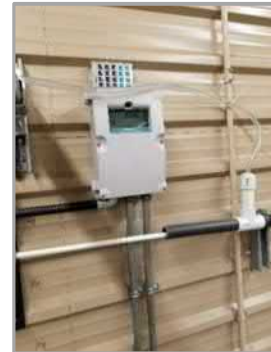
- The Commission has a dedicated level transmitter, a Siemens Milltronics MultiRanger 100 unit that is also in good condition. The magnetic control pad is mounted on top of the unit but should be stored inside the PLC cabinet so as to not get lost.

- It was observed that the Hamlets local level transmitter and the Commission's unit do not read the same and there maybe a reason due to where the readings are taken but it was noted as a concern by the County operators. Further investigation may be warranted but the reading difference has no significant effect on the operation of the facility.

Level Transmitter

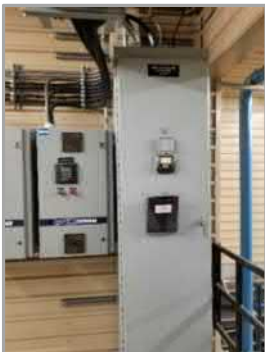
- Flow control valve and Rotork actuator appear to be in good condition as well but flanges are rusted. The corrosion needs to be addressed.
- PLC cabinet wiring is in good condition.

PLC Cabinet

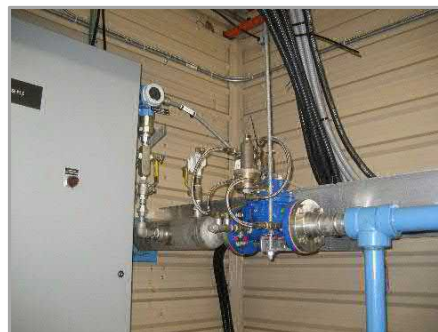
- The fill system is a mixture of carbon steel and stainless-steel piping. The piping is in generally good condition, although there is some superficial rusting on the flanges holding the control valve, and on some of the threaded fittings.
- Control valves are in good condition and appear to be functional.

Valve Condition

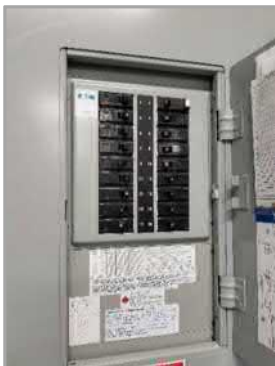
Distribution Panel; Sched is Blank

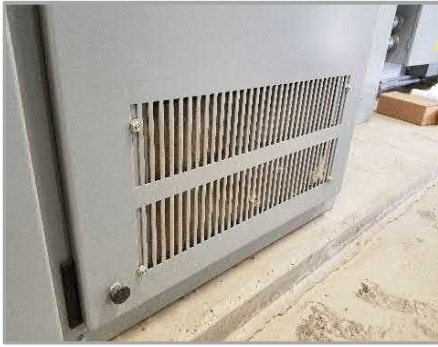
VFD Intake Filter; Plugged

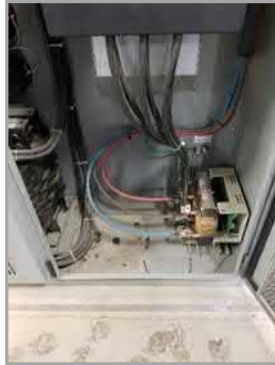
- The electrical equipment appears to be in good condition with no obvious signs of corrosion but given how new the station is none was expected. Typical electrical equipment if maintained can last 20 to 25 years.
- The 18 CCT 120/208V distribution panel schedule is blank. There is no way to determine what breaker operates what device. Recommend this be rectified immediately.
- The PDP has a surge suppressor but no local power meter.
- The PDP was not opened but the VFD inlet screens and internals are dirty and covered in dust. Inlet filters need to be changed and the insides of the VFD cleaned out of the dust. Dust will increase heat retention in

the drives and shorten their life expectancy. Recommend the PDP be serviced as well by qualified personnel. Based on observation the PDP is expected to be dusty as well.

VFD interior; dusty

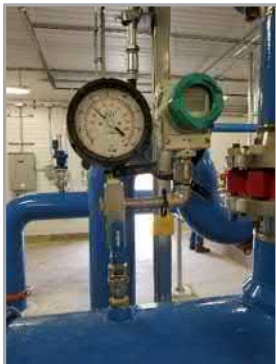
Odd Gauge Arrangement

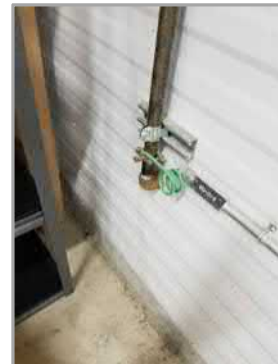
- Gas piping has a secure ground and pumps are bonded.
- Process piping appears to be missing a permanent bonding connection as required by code. Recommend this be rectified.

Gasline Grounding

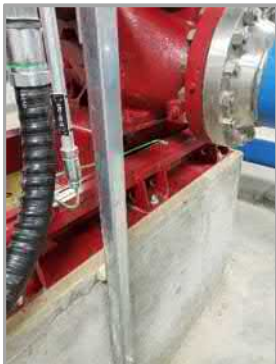
Pump Bonding

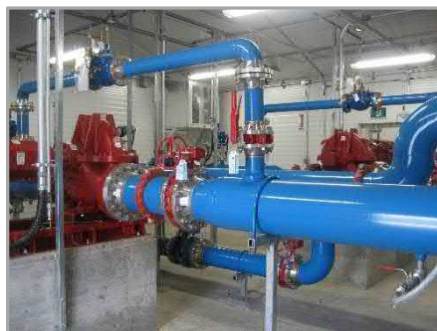
Image Table 2-27
Telford Booster Station – Piping and Valves

- Piping and equipment are in good condition, which is to be expected as the facility is only 2-3 years old.
- Pumps VFD-101 & 102 are each rated at 157.1 L/sec @ 67 m TDH (2,490 USgpm @ 220 ft TDH).
- VFD-101 actual reading – 10.25 L/sec @ 18.8 m TDH (29.6 Hz./888 rpm).
- VFD-102 actual reading – 6.49 L/sec @ 40.3 m TDH (43.3 Hz./1,299 rpm).
- See the table in Appendix A for design vs. actual comparisons of flow and pressure, and the accompanying curve for design vs. actual reading calculated to full speed.
- Both pumps are operating close to their design curve, but both were operating very inefficiently due to low flow conditions at time of observation.
- Vibration readings for both pumps and motors were within acceptable limits.

Equipment and Piping

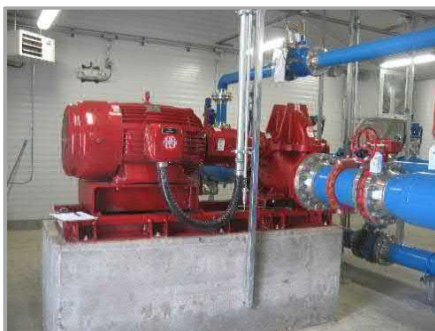
VFD-101

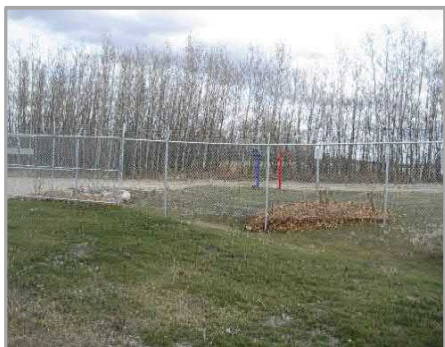
Gap Under Fence

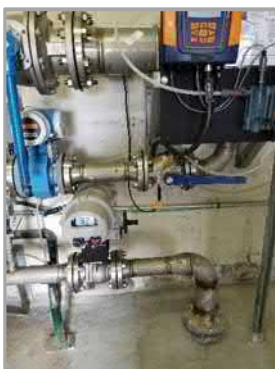
CL₂ Analyser and Piping

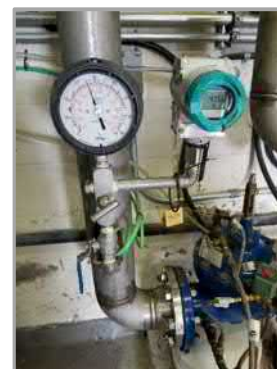
Odd pressure Gauge Arrangement

- Not all the PLC card slots have protective covers. Recommend adding missing covers to the terminal ports on the backplane to prevent contamination.
- The same issue with Pressure Transmitters and Gauges as identified in the Telford Lake booster is seen here. The piping is non-standard and will allow for air to trap in the line going to the transmitter. Recommend the two pressure trees be reconfigured such that the piping goes line tap -> isolation valve -> tee -> gauge and from the other tee half -> Block and Bleed valve -> pressure transmitter. This configuration will ensure air is never trapped at the transmitter.

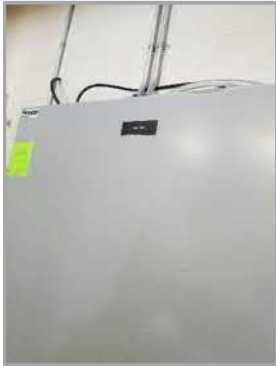
PLC Cabinet

- The PLC cabinet does not have a power filter. AE recommends that a power filter like an Eaton AEGIS unit be used to pre-filter noise from the power line before it reaches the UPS.

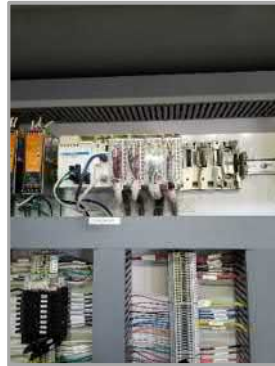
PLC Rack

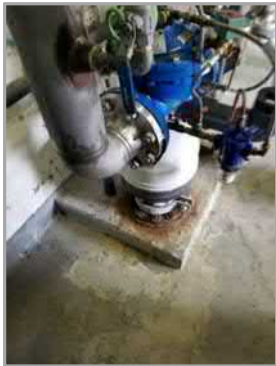
Bad Welding, PRV and Level

- Piping (and valves) are all stainless steel. Piping is in generally good condition; the welding is very poor.
- Valves are relatively new and in good condition. All appear to be functional.
- PRV blocks access to the level transmitter.

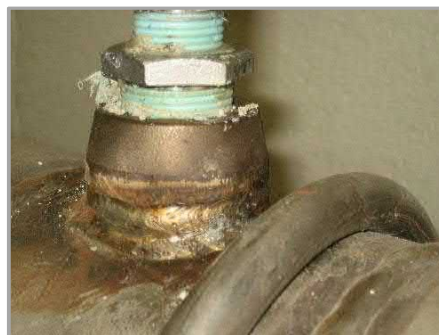
Welding Quality

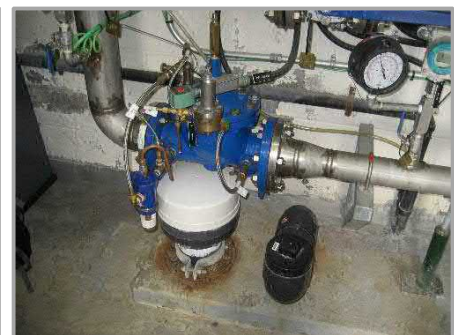
Level Transmitter Access Blocked
